# Chatfield Reservoir Recreation Facilities Modification Plan

Colorado Water Conservation Board in association with Colorado State Parks

EDAW | AECOM

January 2010

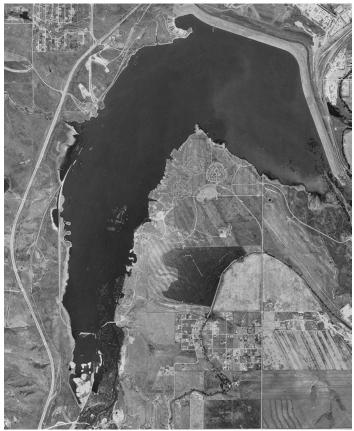
Aerial photograph from 1980 showing a flood at 5443' elevation. Notice that there were fewer facilities at this time, and some are inundated.

has stored water on several occasions that otherwise would have contributed to downstream flooding. The aerial photo below depicts the reservoir at an elevation 5443.1', which is more than 10-ft above the normal maximum elevation of 5432'. As can be seen in the photo, the high water that occurred on June 4, 1980 inundated many of the state park's developed use areas and facilities. Remarkably, the water elevation shown in the photo is less than a foot below the operating level addressed in this reallocation study, thus providing a good indication of what areas would be affected by an increase to 5444'.

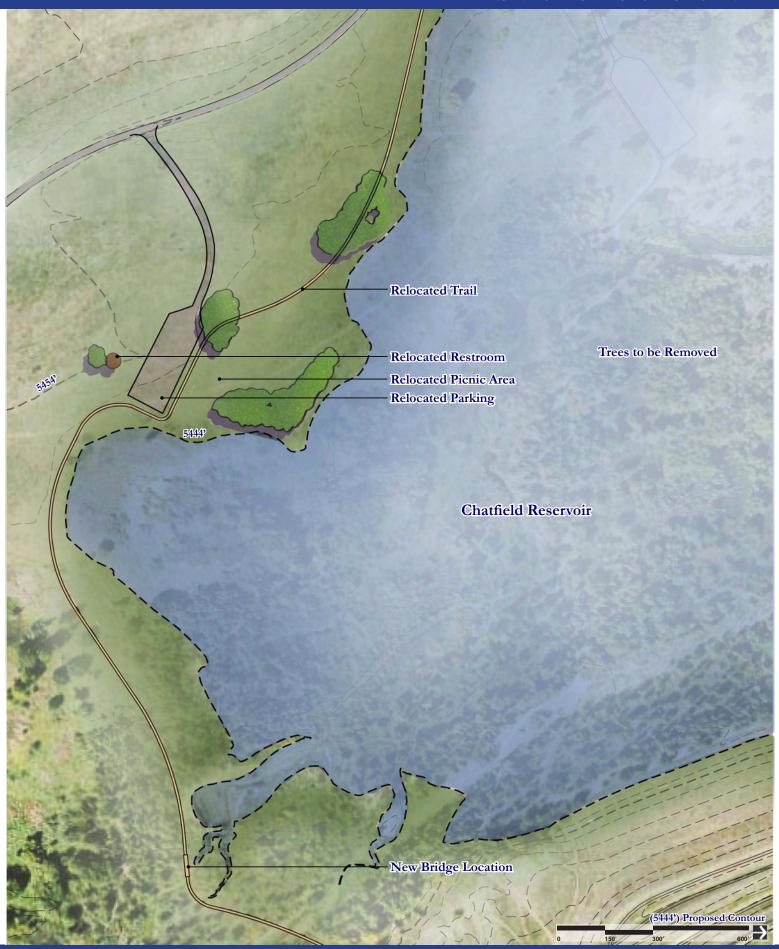
- Plum Creek Day Use Area is entirely inundated at the proposed water elevation.
- The area would be relocated to the southern edge of the reservoir. The recreational facilities would be replaced at this location and a new restroom would be built.
- The Plum Creek trailhead would be relocated to this area and inundated trail segments replaced. A new trail bridge would be built to span Plum Creek.
- The existing sanitary sewer line will need to be relocated as it is below the 5444'.

The relocation concept for this area is shown in Map 3.7.
